Bruce S. Kaskel

The Metal and Glass Curtain Wall

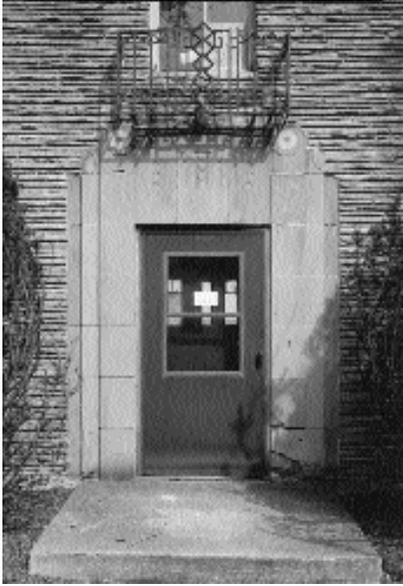
The door surround on the Wieboldt-Rostone House (Walter Scholer, 1933) is the only area of the exterior where the original building material, Rostone, a precast form of simulated masonry, is intact.

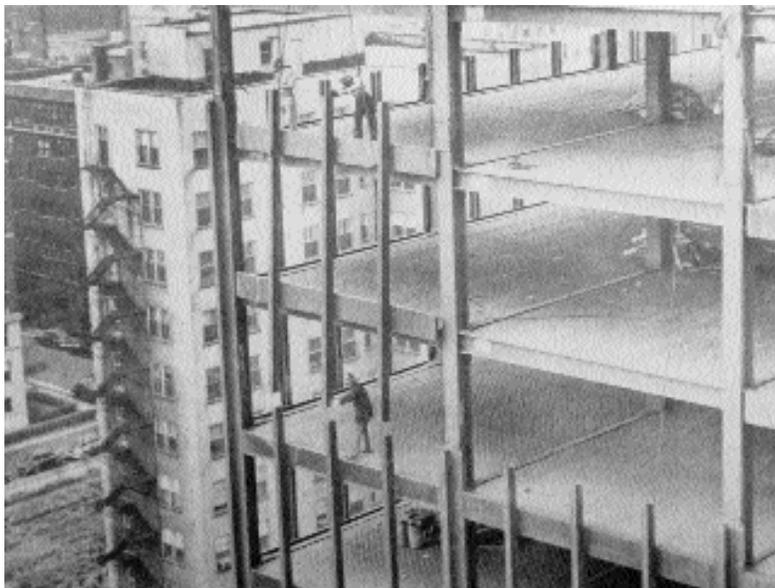
Fig. 1. Construction photograph of 860-880 Lake Shore Drive apartment buildings, Chicago, Illinois (Mies van der Rohe, 1949-1951). These were among the first residential buildings in the United States to be clad entirely in glass, with a two-story prefabricated steel and aluminum curtain wall system.

The principal forms of aluminum were twofold: rolled aluminum sheet, which was flattened and stamped to create opaque wall panels; and extruded aluminum shapes, made by forcing the molten aluminum through a steel die. Extruded aluminum resulted in long lengths of aluminum of almost any cross sectional shape, only limited by the possibilities in die fabrication. Aluminum extrusions were highly consistent in dimensional qualities and were therefore usually employed as the principal framing members of curtain walls. Figure 1 shows the installation of fabricated sections at Mies van der Rohe's 860-880 Lake Shore Drive apartment buildings in Chicago.

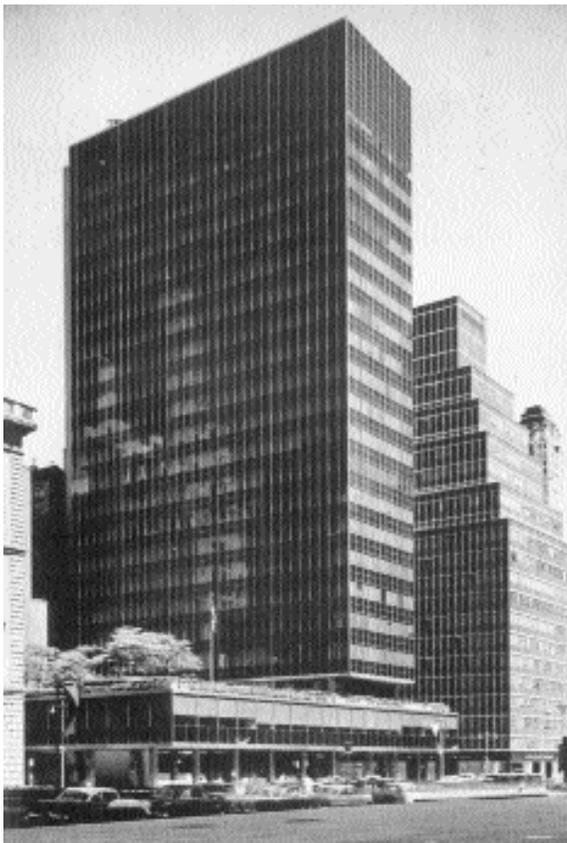
Fig. 2. Lever House, New York, New York (Skidmore, Owings and Merrill, 1952). The clean curtain wall appearance "belies its complex internal construction which was cobbled together from off the shelf parts," as described in Architectural Record, June 1989.

style aluminum windows held in place with a grid of reinforced mullions. Many early "all-glass" curtain walls were actually backed by concrete block walls at each floor behind opaque glass, to satisfy prevailing fire code requirements. Lever House in New York, shown in Figure 2, is an example of early curtain wall construction in the United States. The all glass building also suffered from a lack of consider-

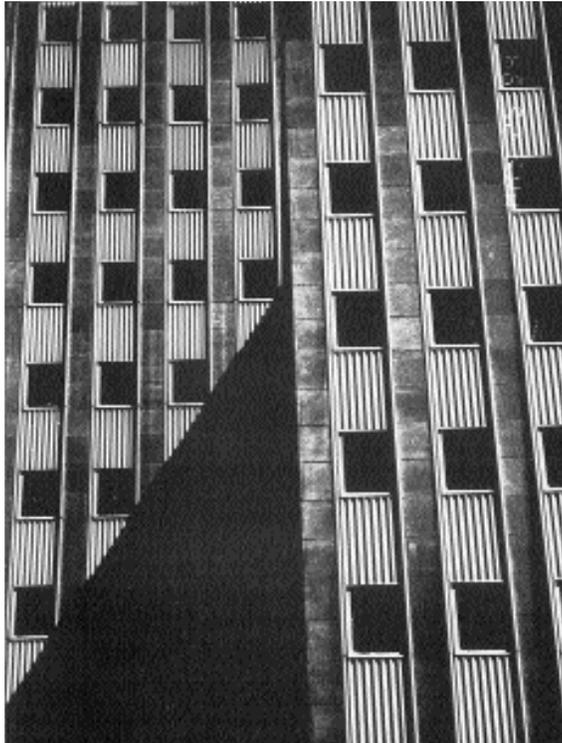
Fig.3. An early aluminum curtain wall used in conjunction with the then more traditional limestone curtain wall. The fluted aluminum spandrel plates and center pivot windows have contributed to water leakage over the years.

Sealant replacement is the most common maintenance requirement for the middle-aged metal and glass curtain wall. Figures 3 and 4 show an early curtain wall and the maintenance for its continued performance. Early generations of polysulfide sealants become embrittled over time and will no longer stop water entry into the wall. "Mono" sealants can harden and contribute to glazing failures due to the sealant compressing the glass. Butyl sealants, which remain flexible over time, can be pushed out of the sealant joint by the repeating action of winds pushing against the aluminum and glass. Old sealants can usually be replaced by cutting out the old material and clean-

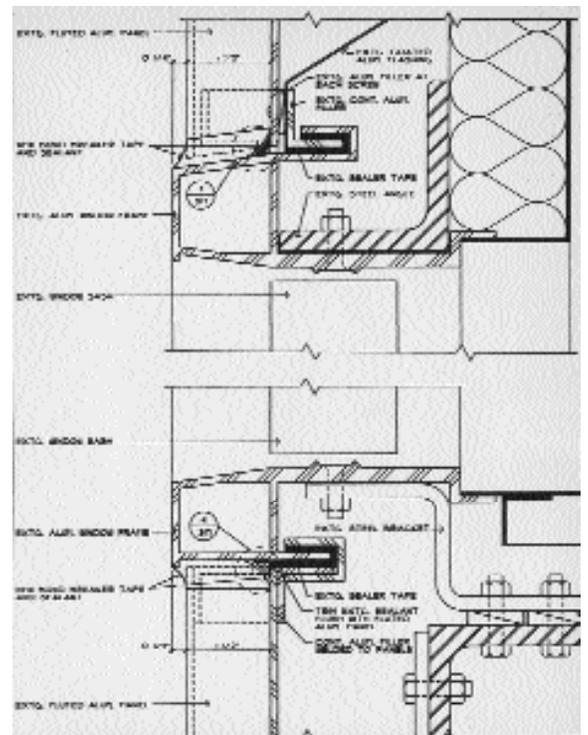
Fig.4. A section at the window head and sill conditions for the curtain wall shown above. Sealant repairs have been specified at key locations to mitigate water leakage.

ing the substrate with a suitable solvent and clean cloth wipe. Then after preparation, the new material can be installed in a properly designed new sealant joint.
